2010 National Atmospheric Deposition Program Site Survey Program Annual Report

**U.S. Environmental Protection Agency
Office of Atmospheric Programs**

June 2011

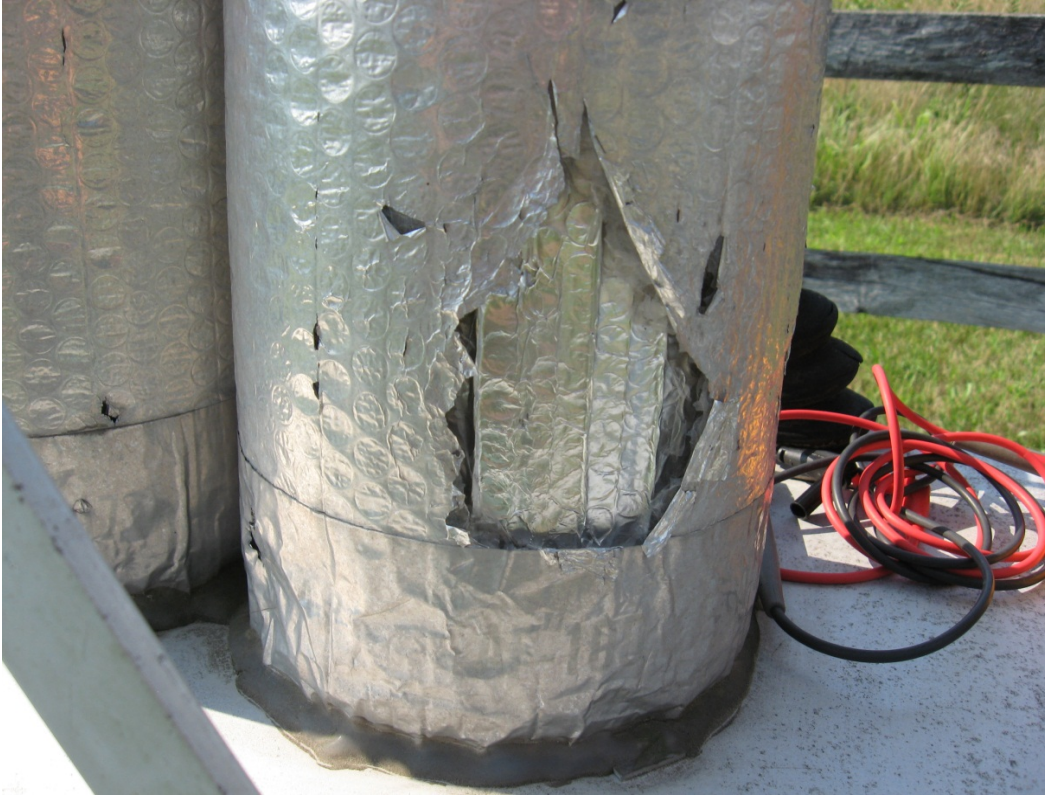
Figure 5-1. – ACM MDN Chimney Insulation

Many of the MDN sites also have chimney insulation that is showing signs of severe deterioration. It may be necessary to implement a procedure and schedule for insulation replacement for ACM MDN collectors. A photo of a chimney that requires replacement insulation is included in Figure 5-1.

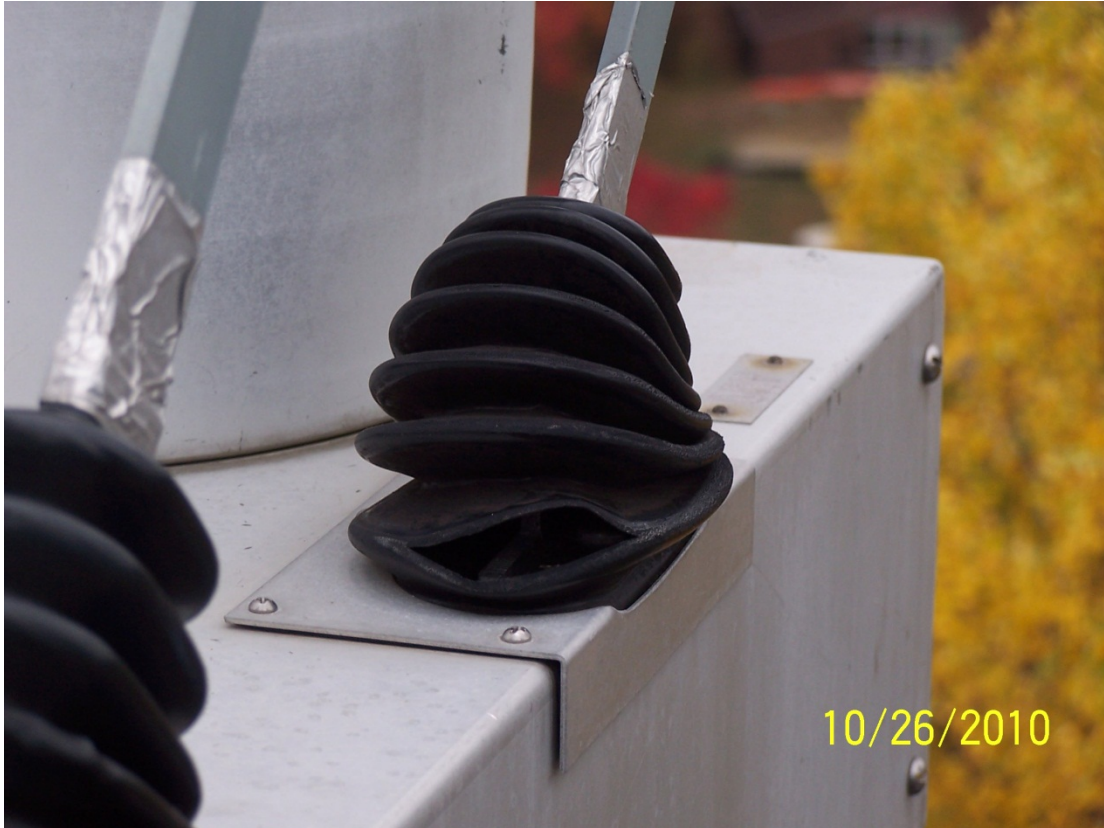
Figure 5-2. – ACM MDN Boot Cover for Collector Arm

At least one site was operating a collector with deteriorated boot covers for the collector arms. This was reported during the survey and a replacement set was requested. Due to the expense of the current approved boots it is suggested that efforts continue to identify other acceptable materials for boot covers. A photograph of a deteriorated boot cover is included in Figure 5-2 below.

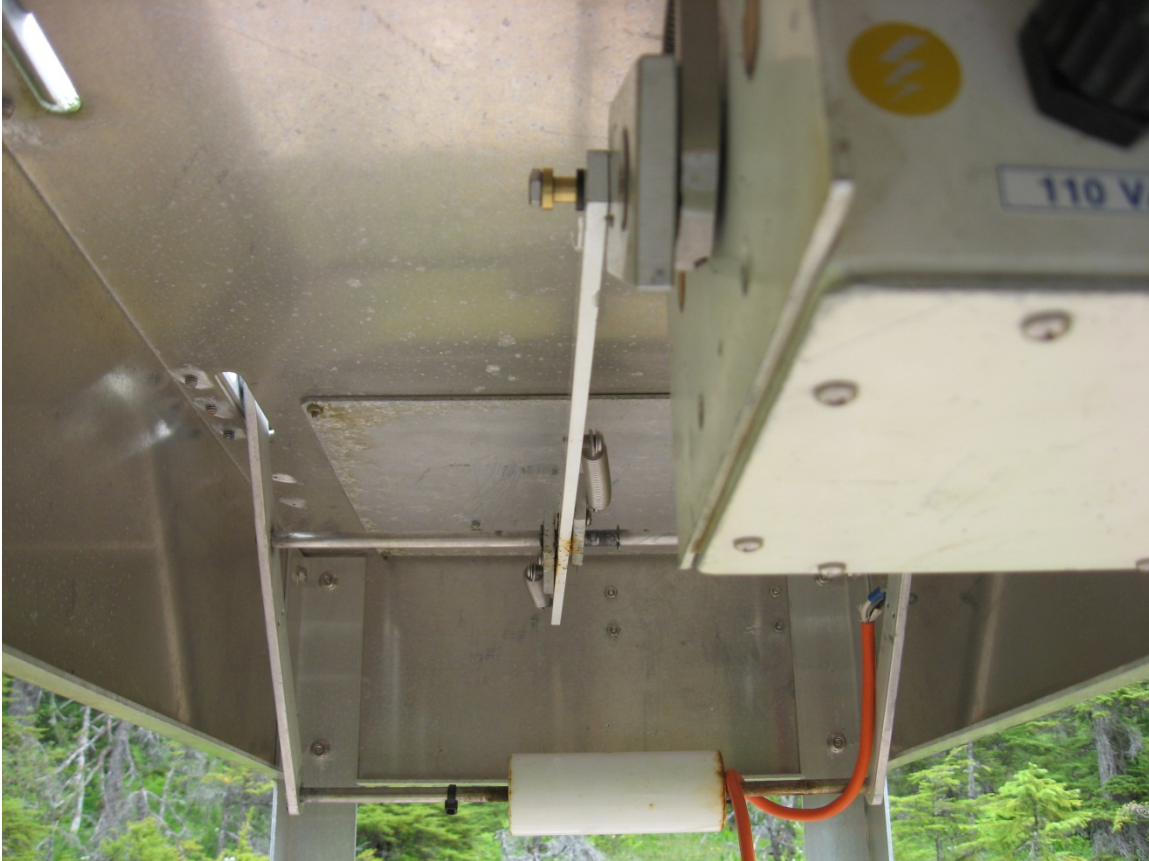
Figure 5-3. – ACM Motor-Box Linkage Misaligned

documentation for that procedure to be sure it is clear as to how to reattach the linkage after installing a motor-box. A photo of a misaligned linkage is included in Figure 5-3 below.

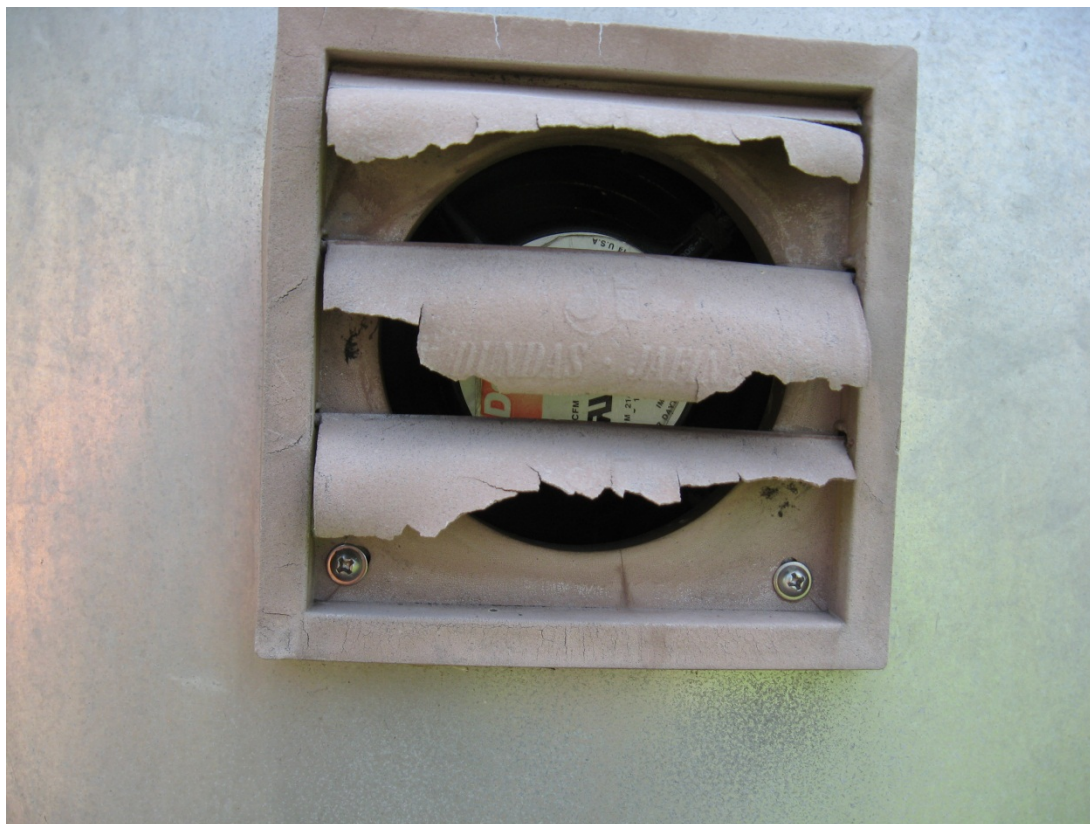
Figure 5-4. – ACM MDN Cooling Fan Louver

Some of the older ACM MDN collector fan louvers are beginning to deteriorate. It may be necessary to implement an inspection and replacement schedule for the louvers. A photograph is included in Figure 5-4 below.

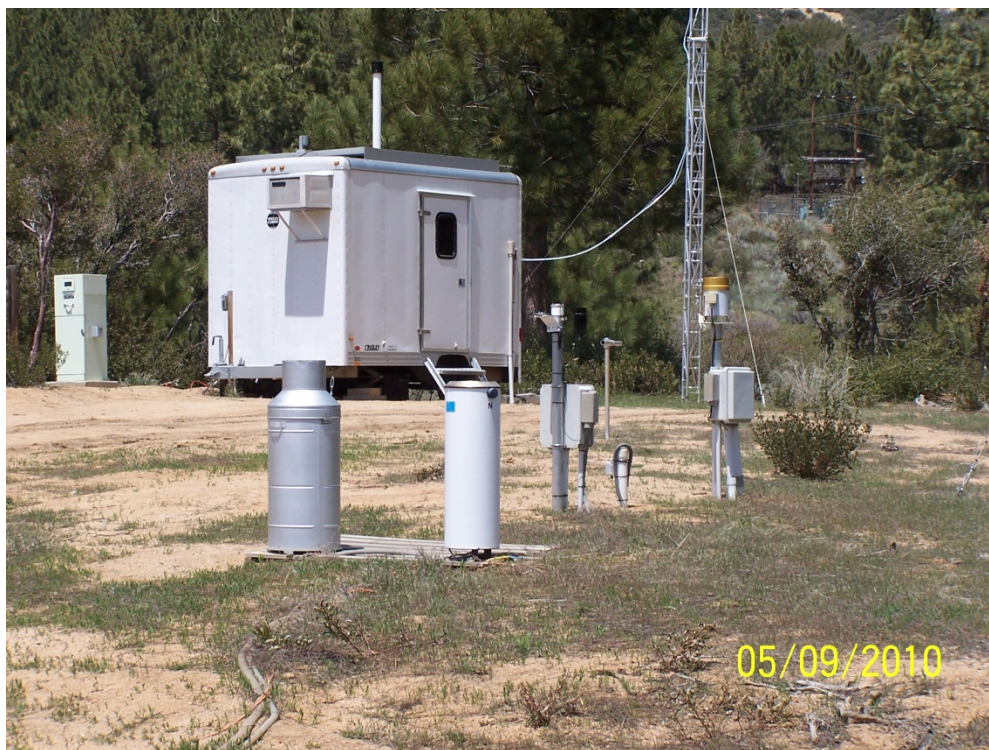
Figure 5-5. – Objects Within 5 Meters

It was observed that some of the electronic gage installations were not performed according to the guidelines and rules provided by the NADP. Photographs are included in Figures 5-5 and 5-6 below.

EEMS recommends that when site upgrades are planned, such as the installation of new electronic gages, that care should be exercised to improve the site conditions with respect to siting criteria issues and instrument operation. It may be necessary to review the rules and guidelines with the installer prior to the installation to ensure compliance.
