# **2011 National Atmospheric Deposition Program Site Survey Program Annual Report**

**U.S. Environmental Protection Agency  
Office of Atmospheric Programs**

**August 2012**

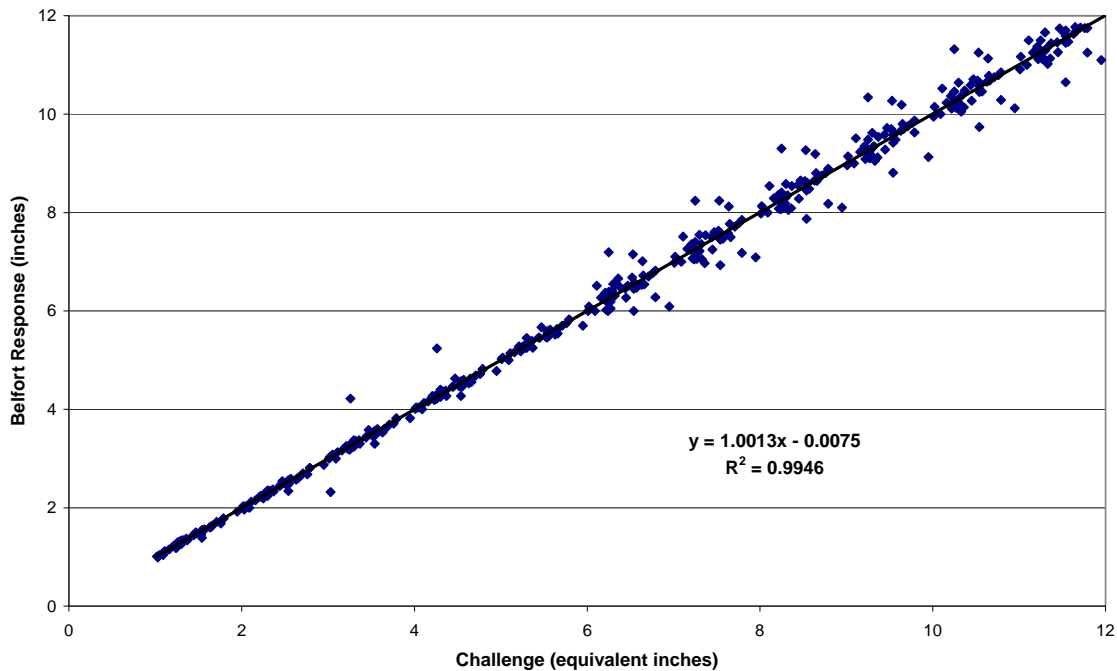
Figure 4-1. As Found Belfort Accuracy Results - 47 Gages

Figure 4.1 presents the “as found” Belfort raingage accuracy results for 48 Belfort raingages encountered during the period covered by this report. At co-located sites the same gage measures precipitation data for more than one network (i.e. MDN and NTN). Data presented here represents precipitation data as a whole, and is not related to any one network of NADP.

Overall program-wide Belfort raingage accuracy was found to be very good with a slope of approximately 1.00 and a correlation coefficient of 0.9946. A relatively few number of sites were not performing well and are easily identifiable in Figure 4-1.

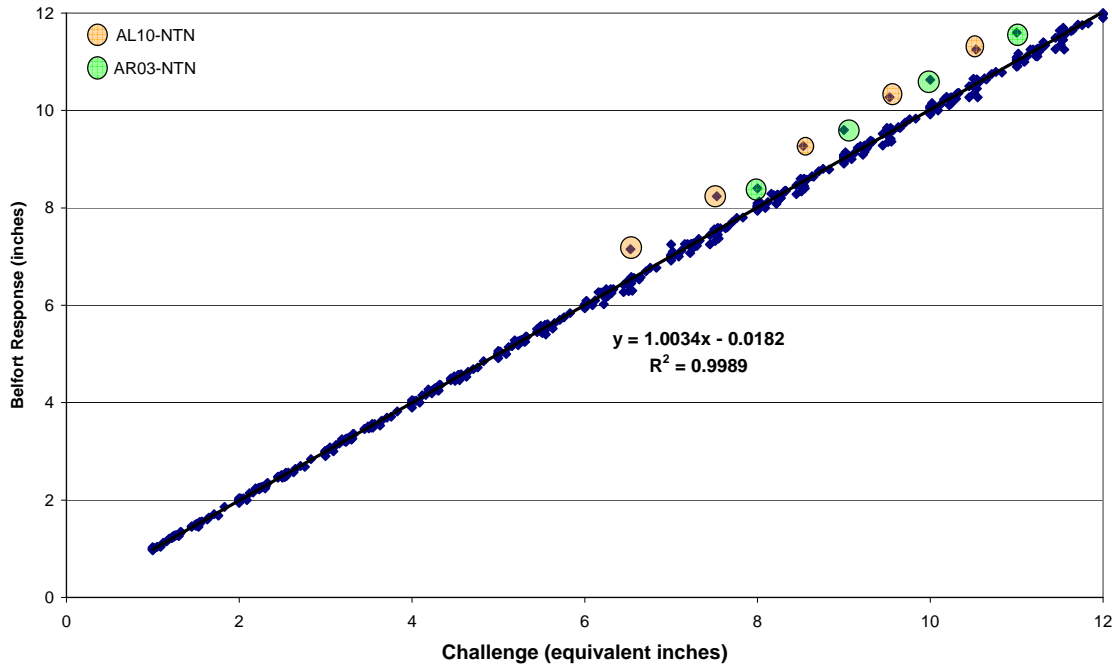
Figure 4-2. As left Belfort Accuracy - 47 Gages

Figure 4-2 presents the “as left” Belfort raingage accuracy results for all gages encountered following any adjustments or improvements to the operation. Adjustments include leveling, cleaning, adjusting linkage, and calibration. Overall program-wide accuracy was improved as the results indicate with a slope of approximately 1.00 and a correlation coefficient of 0.9989. However there were still some gages that could not be adjusted to within the tolerance of 0.10 inch throughout the entire range of 0-12 inches. Site AR03-NTN was not able to be adjusted within acceptable limits. Adjustment of the gage at site AL10-NTN was not attempted since the Belfort gage was scheduled to be replaced with an electronic gage a few days after survey.

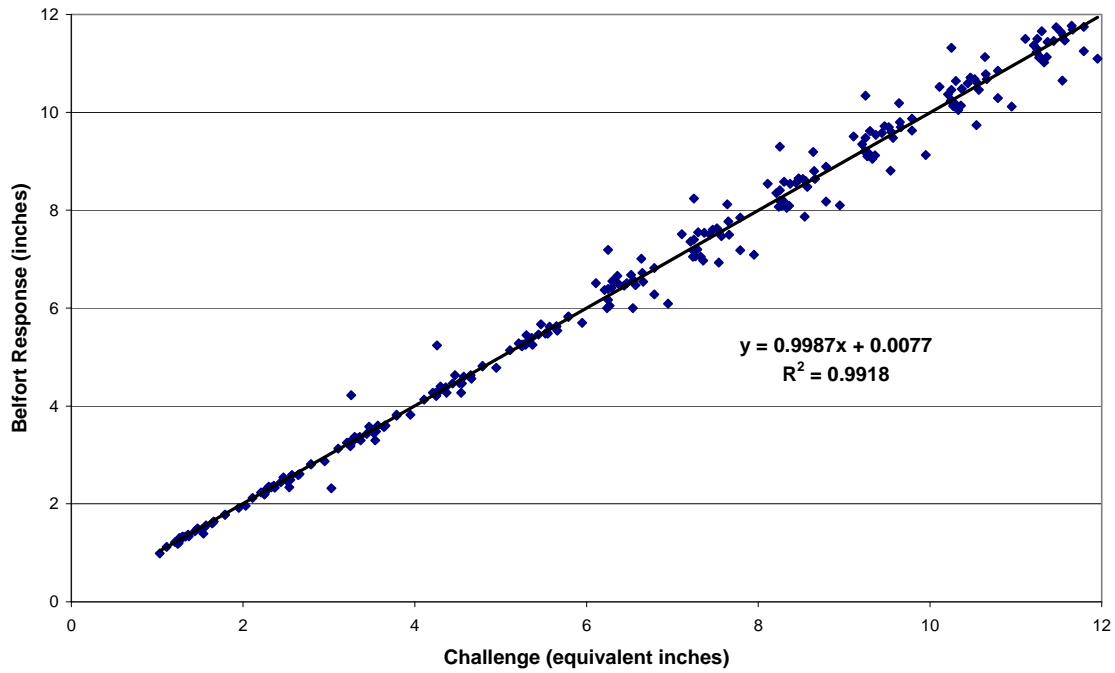
Figure 4-3. As Found Belfort Accuracy - 26 Adjusted Gages

Of the 48 Belfort gages encountered, 26 gages required some type of adjustment. Only data from Belfort gages that were adjusted during the survey are presented in this subsection. Gages that were already within tolerance or could not be adjusted to within tolerance are not included. Figure 4-3 presents the “unadjusted” calibration results and Figure 4-4 presents the results after adjustments and calibration. There is a noticeable decrease in accuracy observed in points above six inches in Figure 4-3. This is mostly attributed to improper gage turnover which was discussed in Section 3.0 and will be addressed again in Section 6.0 of this report.

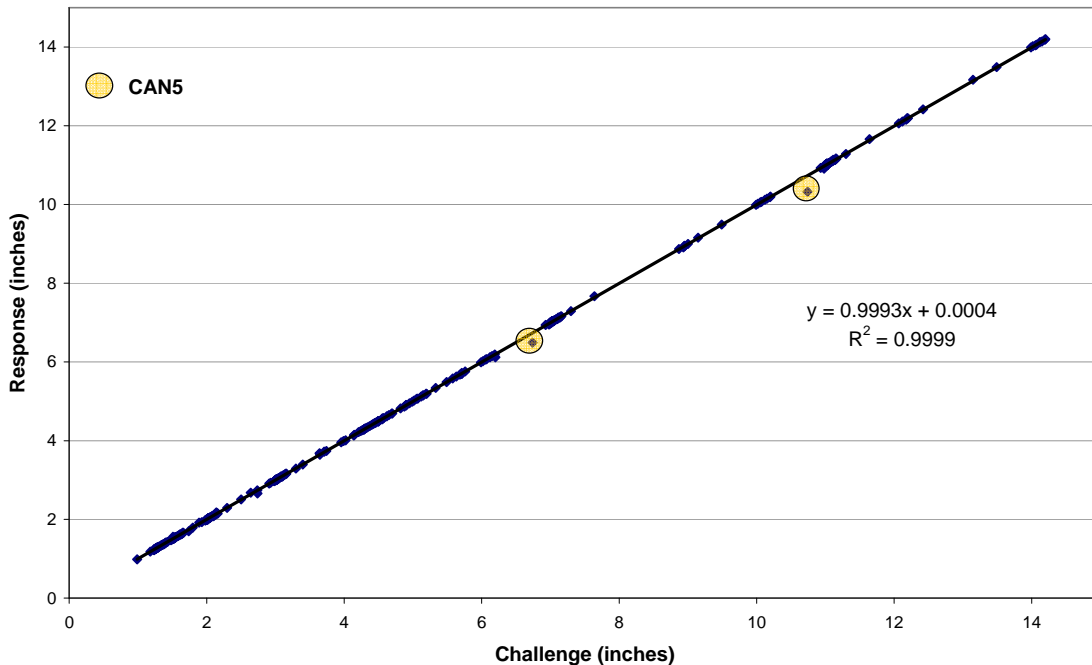
Figure 4-5. As Found Electronic Gage Accuracy - 63 Gages

The results of the accuracy tests for the 63 electronic raingages challenged during the period covered by this report are presented in Figure 4-5. CAN5 was being installed by personnel from Environment Canada at the time of the survey and it was discovered that the calibration factors stored in the datalogger were incorrect. The factors were corrected following the survey and the gage accuracy was verified by Environment Canada personnel.

As demonstrated the gages report the weight of the standards added very accurately for the entire span. No problems with the electronic gages were encountered. As was the case with the gage at CAN5, when a gage is found out of calibration it is identified as requiring further correction. This may necessitate the gage being sent to the manufacturer for maintenance. The only notable problem with the electronic gage operation is related to the Personal Digital Assistant (PDA) and the required interfacing software. This is discussed further in Section 5.0.

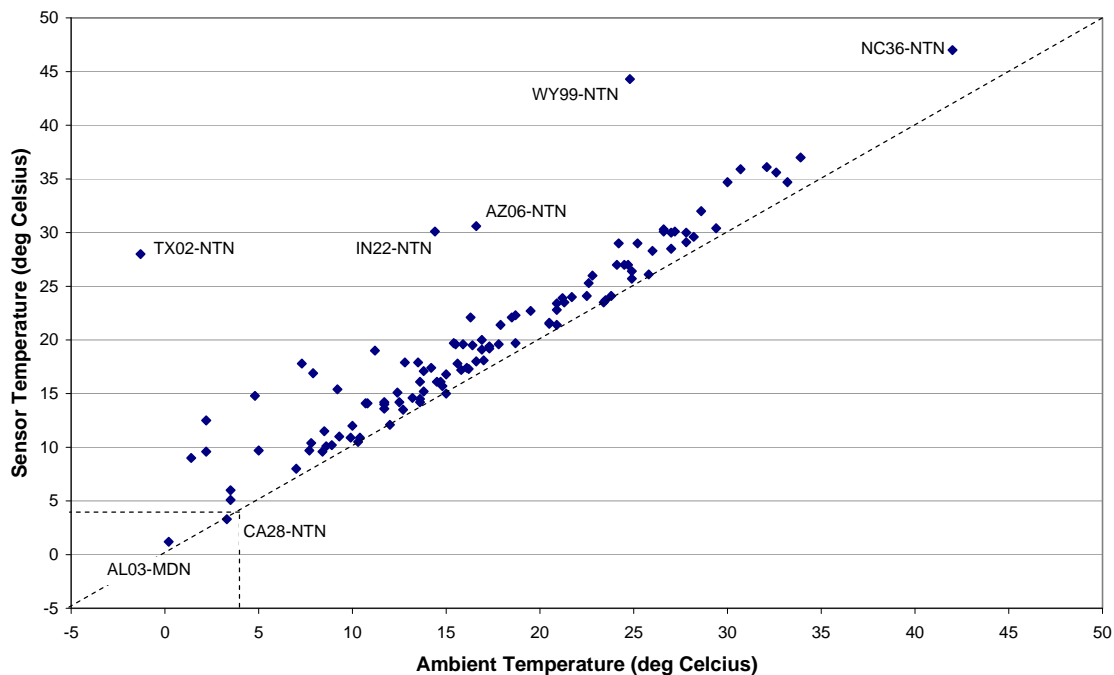
**Figure 4-6. Inactivated Sensor Temperature**

The inactive sensor temperature tests are conducted using a thermocouple with the sensor shaded immediately after measuring the ambient temperature with the same device. The thin thermocouple is placed directly on the sensor plate between the sensor grids without making contact with the grid. The test results are presented in Figure 4-6.

As can be seen in Figure 4-6 a few sensors appeared to be considerably warmer than ambient when the temperature was above 4 °C, and a couple of sensors did not appear to be heating when the ambient temperature was below 4 °C. AL03-MDN was reported as operating properly by the surveyor with no follow-up suggestions. The sensor for CA28-NTN was reported as not functioning properly, and it was suggested that it be replaced. Records indicate that a replacement sensor was sent to the site after the site survey took place.

Replacements for two of the sensors (sites TX02 and WY99) were requested during the site surveys. The other three sites that had sensors at higher than ambient temperature were considered to be reasonable at the time of the test most likely due to residual radiant heat and not enough time shaded prior to making the temperature measurement.

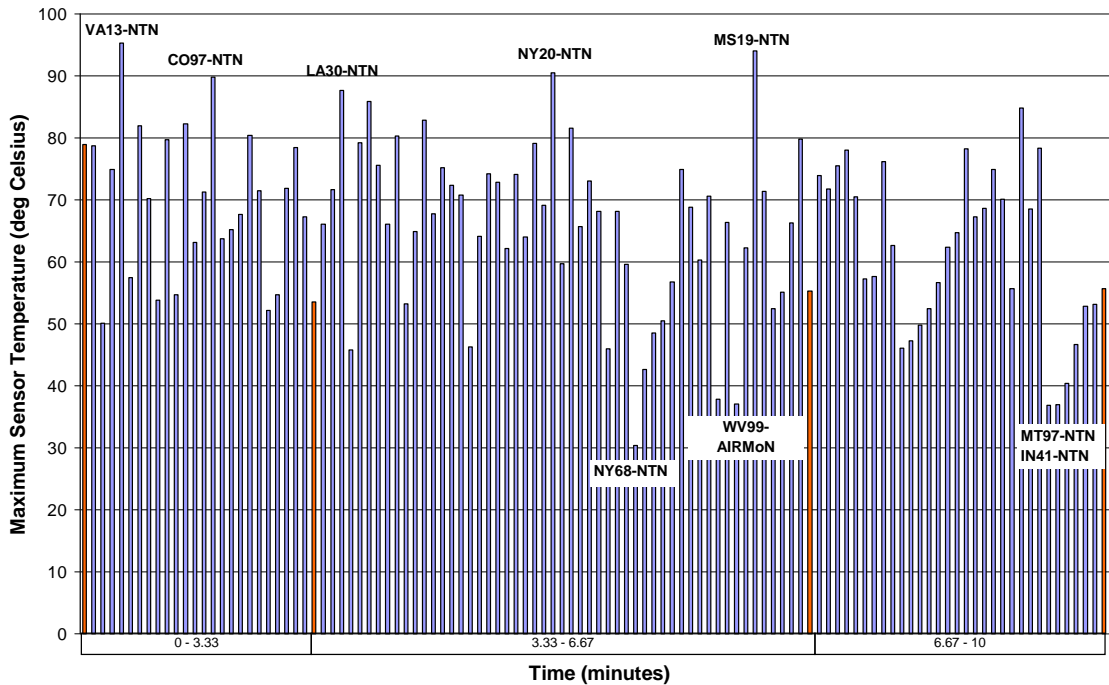
Figure 4-7. Activated Sensor Temperature Increase and Elapsed Time

Figure 4-7 presents the maximum temperature reached by each sensor when activated, and the time required for each sensor to reach that temperature. There seems to be considerable variability between sensors for maximum temperature, but nearly all sensors are generally between 60°C and 80°C prior to 10 minutes of activation. A few sensors did not reach 50°C, however that could be due to low ambient temperature or high wind speed during the test.

Further evaluation of the data presented in Figure 4-7 is provided in Table 4-1, which includes the number of sensors that reached the maximum temperature within each 10 degree range above 30 degrees.
