2014 National Atmospheric Deposition Program Site Survey Program Annual Report

**U.S. Environmental Protection Agency
Office of Atmospheric Programs**

Contract No.: EP-W-12-019

August 2015

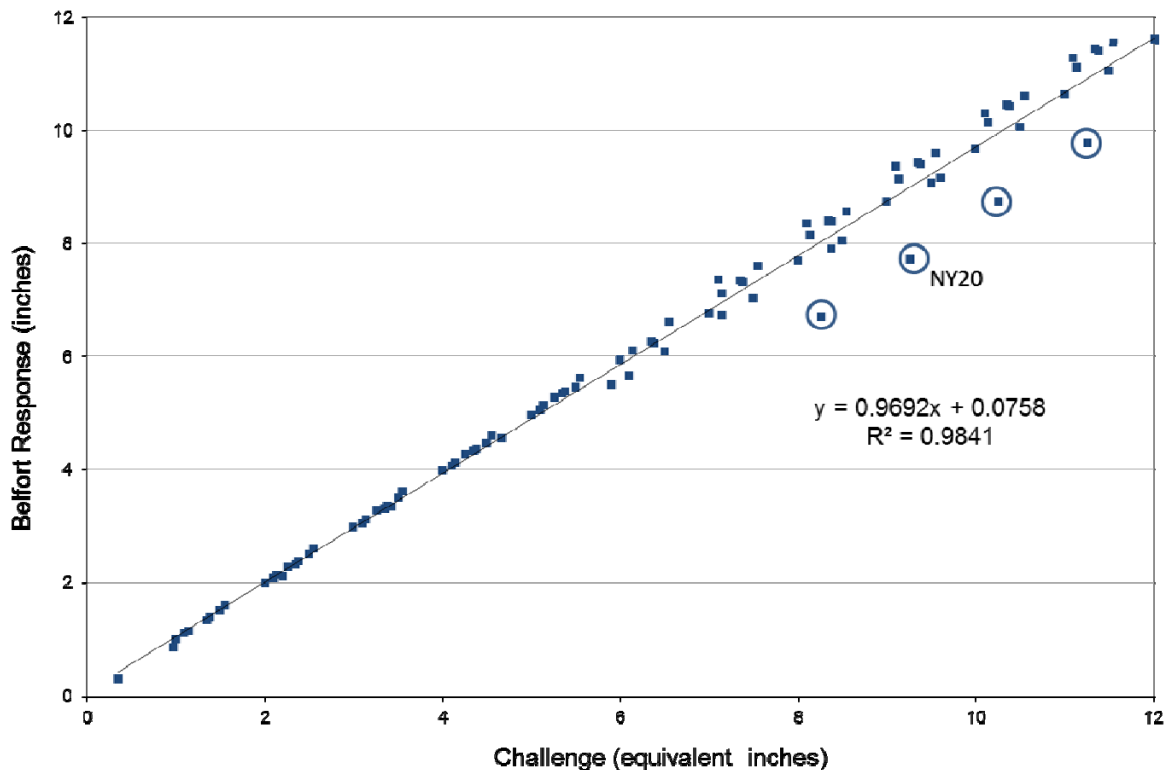
Figure 4-1: As Found Belfort Accuracy - Nine Gages

Figure 4.1 presents the “as found” Belfort raingage accuracy results for nine Belfort raingages encountered during the period covered by this report. At co-located sites the same gage measures precipitation data for more than one network (i.e. MDN and NTN). Data presented here represent precipitation data as a whole, and is not related to any one network of NADP.

Overall program-wide Belfort raingage accuracy was found to be very good. A relatively few number of sites were not performing well and are easily identifiable in Figure 4-1.

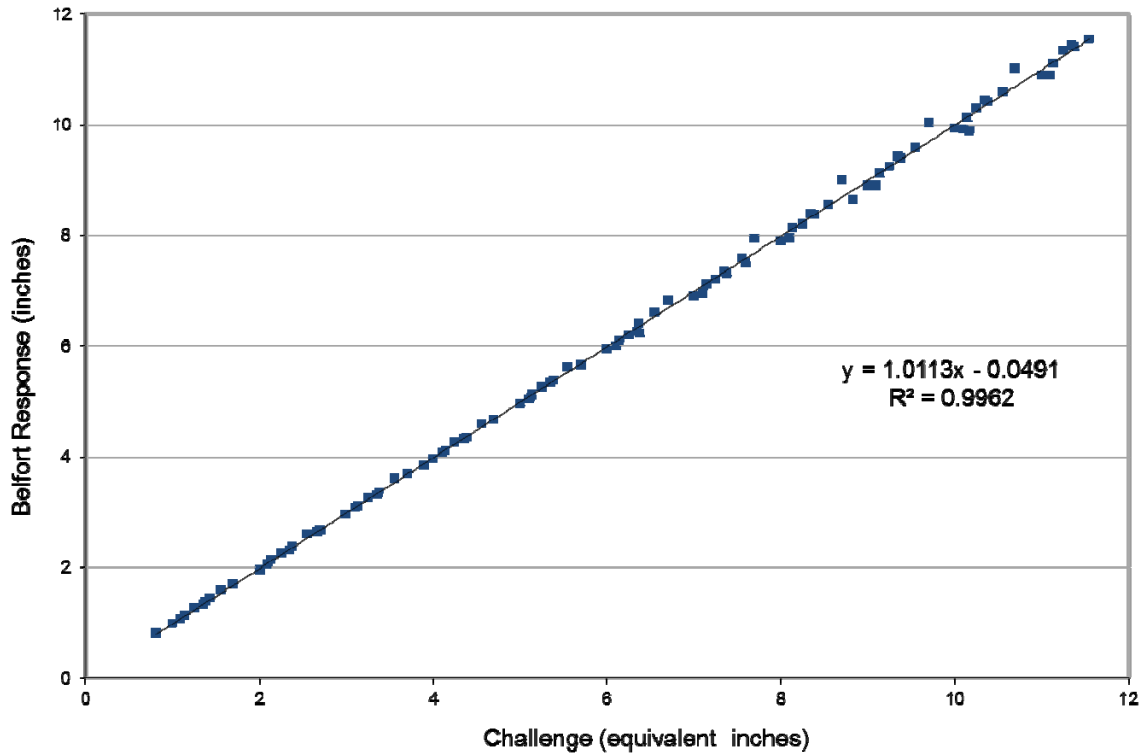
Figure 4-2. As Left Belfort Accuracy - Nine Gages

Figure 4-2 presents the “as left” Belfort raingage accuracy results for all gages encountered following any adjustments or improvements to the operation. Adjustments include leveling,

cleaning, adjusting linkage, and calibration. Overall program-wide accuracy was improved as the results indicate with a slope and correlation coefficient close to 1.0.

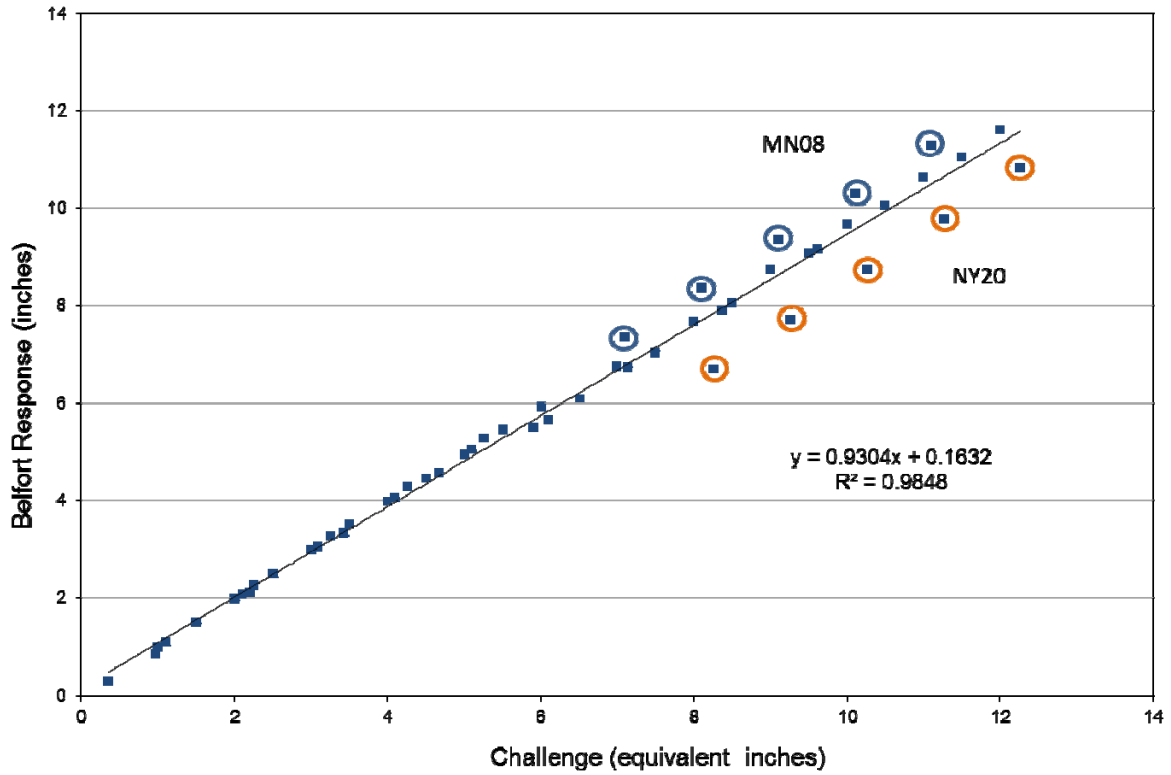
Figure 4-3. As Found Belfort Accuracy - Five Adjusted Gages

Of the nine Belfort gages encountered, five gages required some type of adjustment. Only data from Belfort gages that were adjusted during the survey are presented in this subsection. Gages that were already within tolerance or could not be adjusted to within tolerance are not included. Figure 4-3 presents the “unadjusted” calibration results and Figure 4-4 presents the results after adjustments and calibration. There is a noticeable decrease in accuracy observed in points above six inches in Figure 4-3. This is mostly attributed to improper gage turnover which is discussed in Section 6.0 of this report.

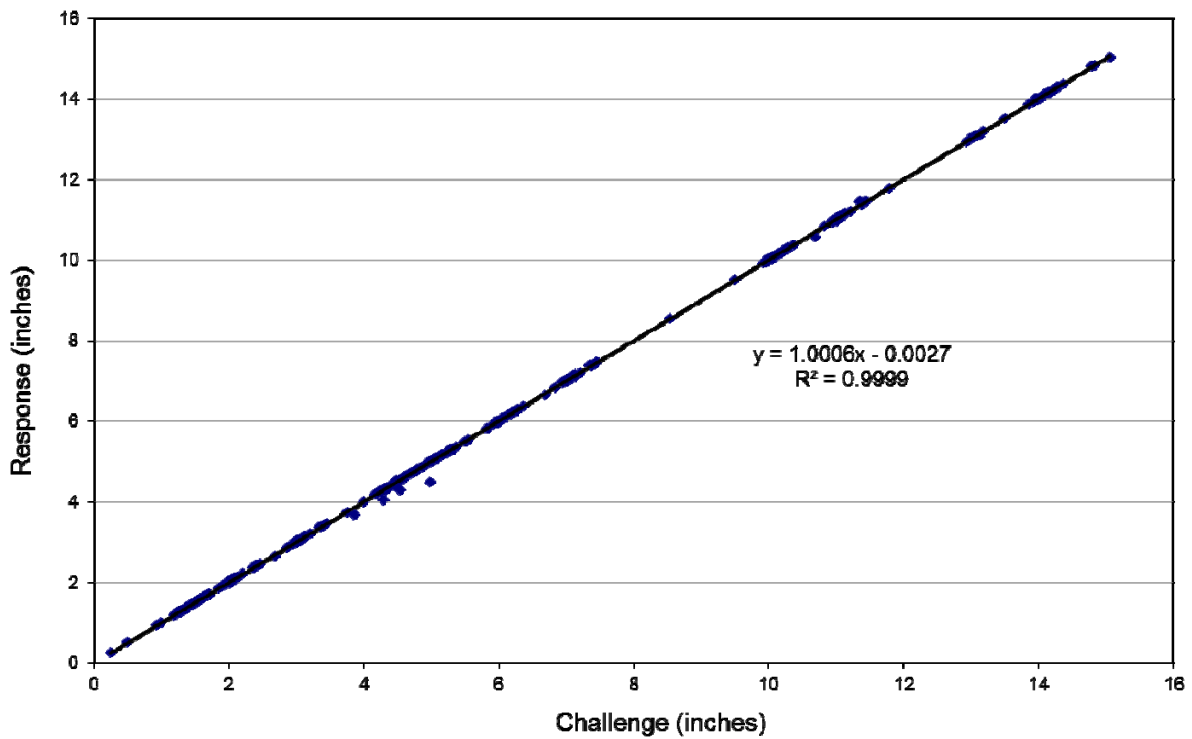
Figure 4-5. As Found Electronic Gage Accuracy - 88 Gages

The results of the accuracy tests for the 88 electronic raingages challenged during the period covered by this report are presented in Figure 4-5.

As demonstrated the gages report the weight of the standards added very accurately for the entire span. No problems with the electronic gages were encountered. The only notable problem with the electronic gage operation is related to the Personal Digital Assistant (PDA) and the required interfacing software. This is discussed further in Section 5.0.

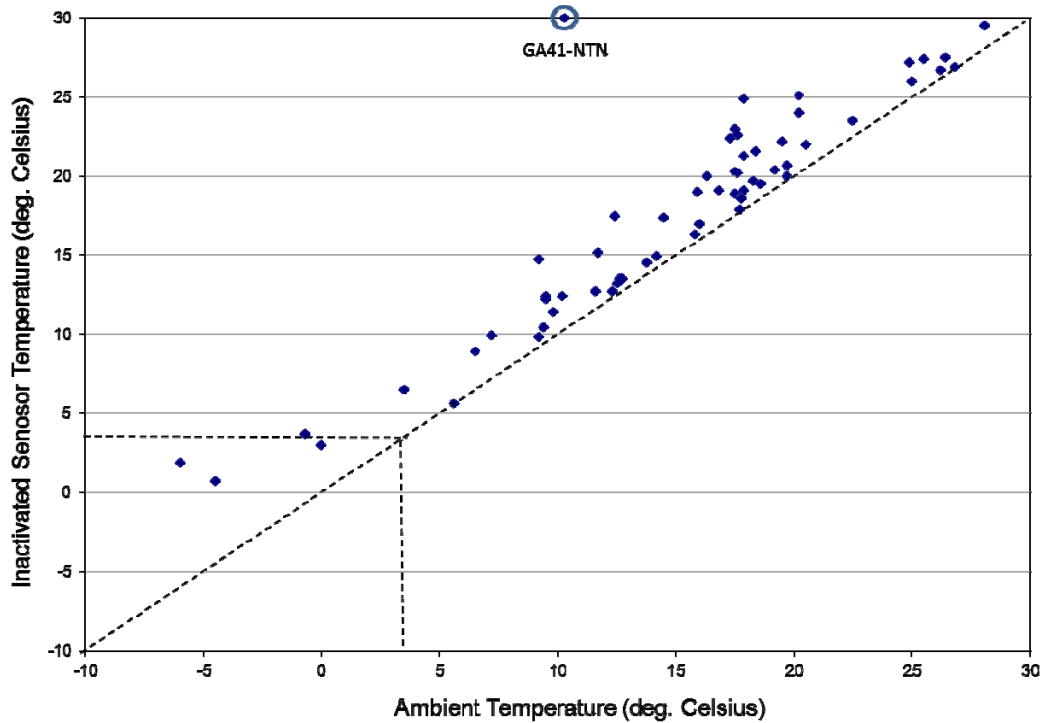
Figure 4-6. Inactivated Sensor Temperature

The inactive sensor temperature tests are conducted using a thermocouple with the sensor shaded immediately after measuring the ambient temperature with the same device. The thin thermocouple is placed directly on the sensor plate between the sensor grids without making contact with the grid. The test results are presented in Figure 4-6. The results indicate that all inactive sensor heaters were functioning properly. GA41 appears to have a sensor that was warm when it was not necessary for the heater to be active. That was most likely caused by the heater being active prior to testing due to the cool morning temperature. The sensor probably had not cooled to ambient temperature prior to the test.

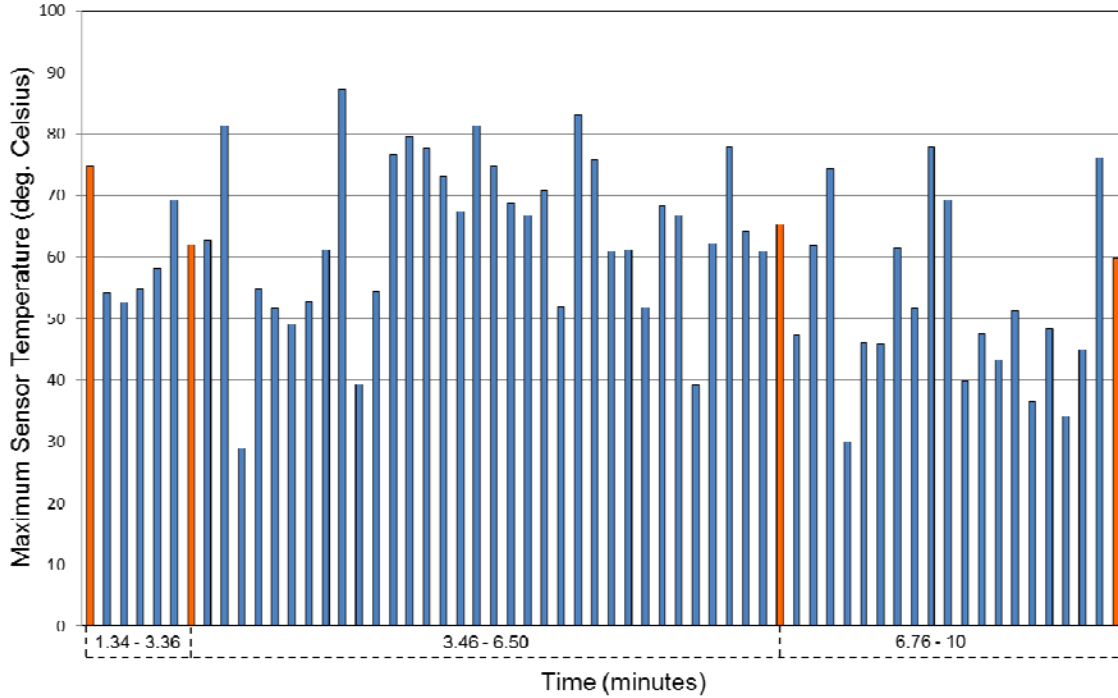
Figure 4-7. Activated Sensor Temperature Increase and Elapsed Time

Figure 4-7 presents the maximum temperature reached by each sensor when activated, and the time required for each sensor to reach that temperature. There seems to be considerable variability between sensors for maximum temperature, but nearly all sensors are between 60°C and 80°C prior to 10 minutes of activation. A few sensors did not reach 50°C, however that could

be due to low ambient temperature or high wind speed during the test. Tests at two sites were conducted at ambient temperatures well below freezing.

Further evaluation of the data presented in Figure 4-7 is provided in Table 4-1, which includes the number of sensors that reached the maximum temperature within each 10 degree range above 30 degrees.
