National Atmospheric Deposition Program Site Survey Program Annual Report

**U.S. Environmental Protection Agency
Office of Atmospheric Programs**

May 2009

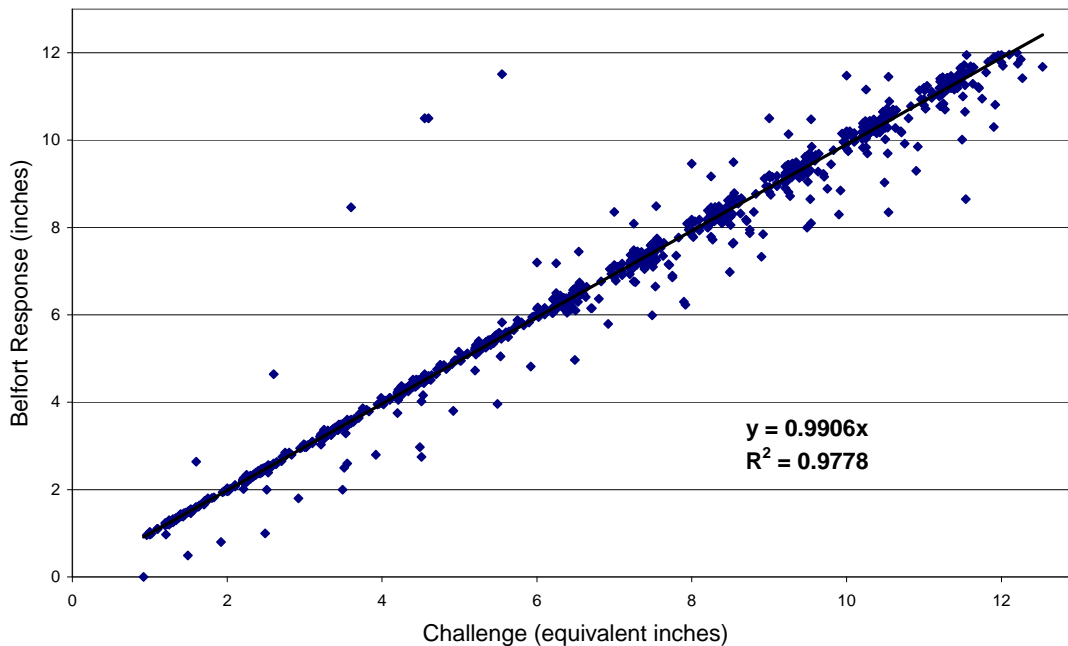
Figure 4-1. As Found Belfort Accuracy Results All Sites

Figure 4.1 presents the “as found” Belfort raingage accuracy results for all Belfort raingages encountered during the period covered by this report. At collocated sites the same gage measures precipitation data for more than one network (i.e. MDN and NTN). Data presented here represents precipitation data as a whole, and is not related to any one network of NADP.

Overall program-wide Belfort raingage accuracy was found to be very good with a slope of approximately 99% and a correlation of 0.9778. A relatively few number of sites were not performing well and are easily identifiable in Figure 4-1.

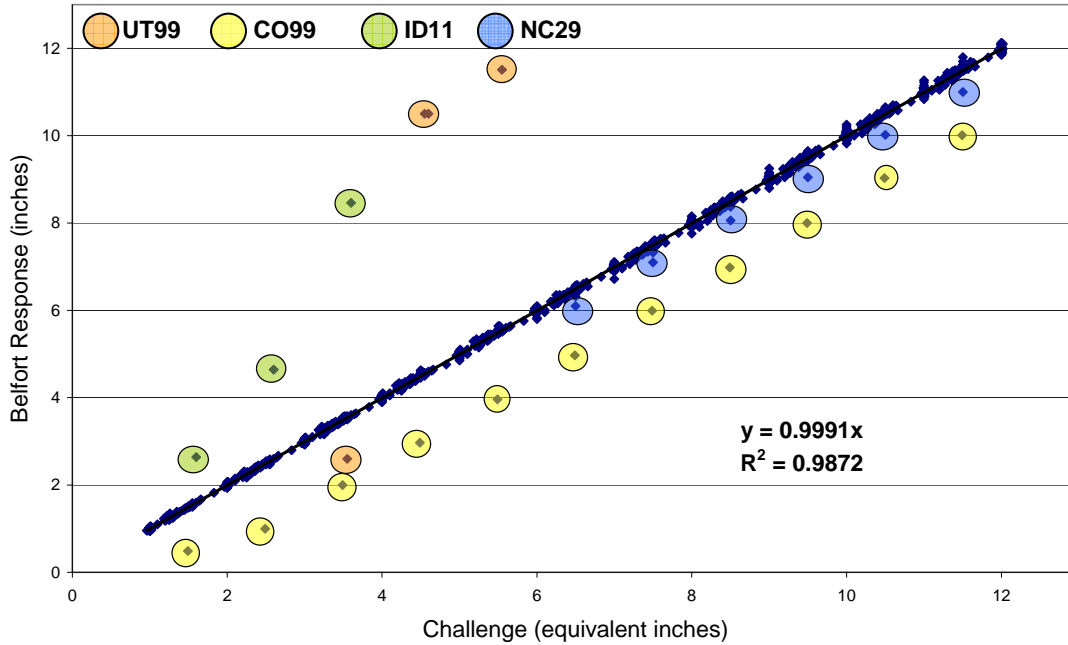
Figure 4-2. As Left Belfort Accuracy Results All Sites

Figure 4-2 presents the “as left” Belfort raingage accuracy results for all gages encountered following any adjustments or improvements to the operation. Adjustments include leveling, cleaning, adjusting linkage, and calibration. Overall program-wide accuracy was improved as the results indicate with a slope of approximately 99.9% and a correlation of 0.9891, however there were still some gages that could not be adjusted to within the tolerance of 0.10 inch throughout the entire range of 0-12 inches. The data denoted with colored circles in Figure 4-2 represent sites NC29, UT99, ID11, and CO99. Other site results are much closer to the tolerance of 0.10

and cannot be distinguished from the line. Replacements were requested for all gages that were not adjusted to within tolerance, or improved to within acceptable operating condition, except for site NC29 which was scheduled to be replaced with an electronic gage within one month from the site survey.

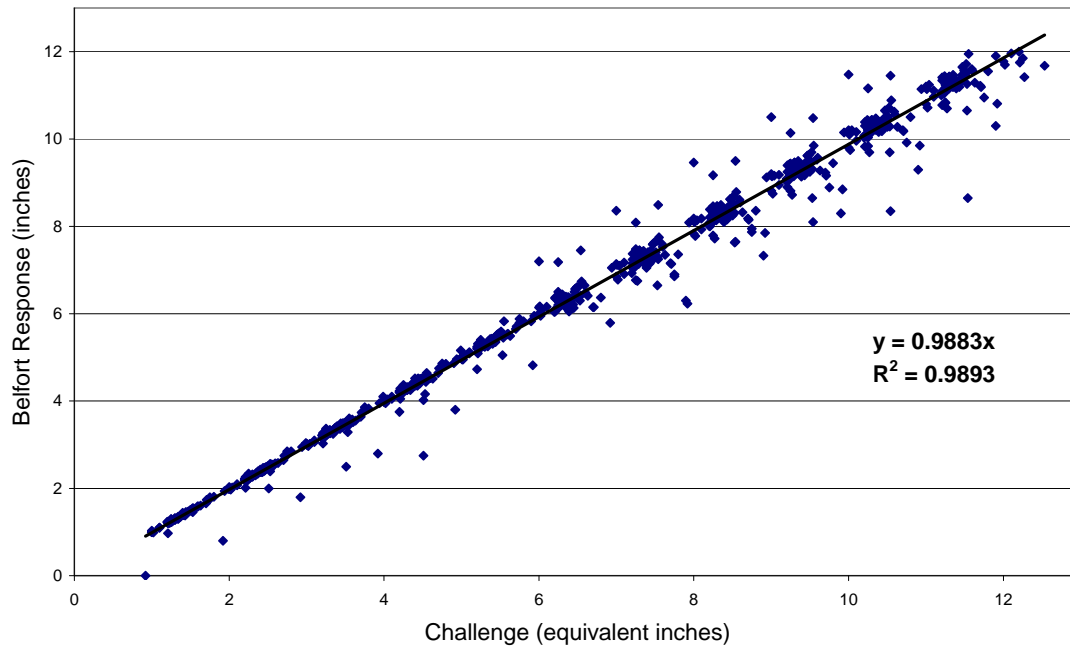
Figure 4-3. As Found Belfort Accuracy Prior to Adjustment

Only data from Belfort gages that were adjusted during the survey are presented in this subsection. Gages that were already within tolerance or could not be adjusted to within tolerance are not included. Figure 4-3 presents the “unadjusted” calibration results and Figure 4-4 presents the results after adjustments and calibration. There is a noticeable decrease in accuracy observed in points above six inches in Figure 4-3. This is mostly attributed to improper gage turnover which was discussed in Section 3.0 and will be addressed again in Section 6.0 of this report.

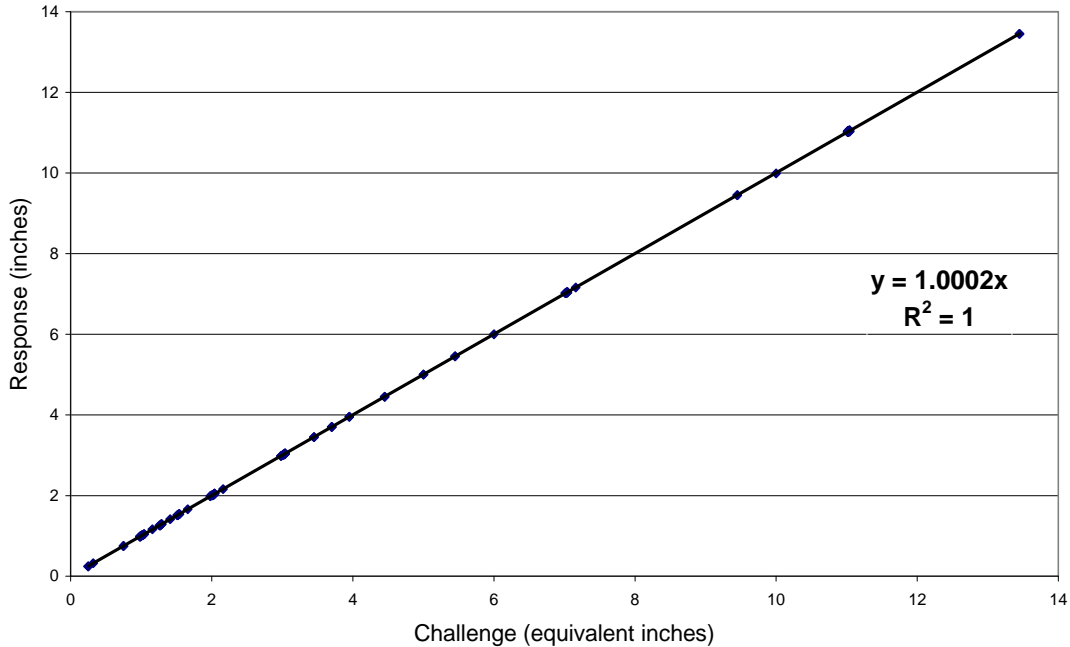
Figure 4-5. As Found Electronic Gage Accuracy

The results of the accuracy tests for the electronic raingages surveyed during the period covered by this report are presented in Figure 4-5. As clearly indicated the gages are very accurate for the entire span. No problems were encountered and no adjustments were required for the electronic gages.

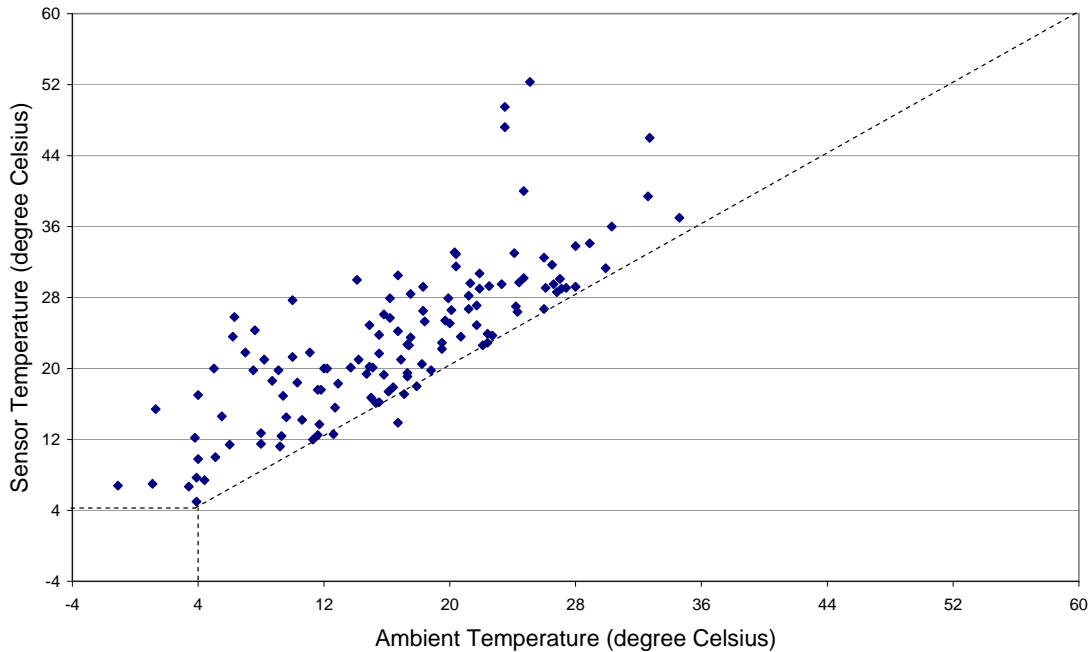
Figure 4-6. Inactivated Sensor Temperature

The inactive sensor temperature tests are conducted using a thermocouple with the sensor shaded, immediately after measuring the ambient temperature with the same device. The thin thermocouple is placed directly on the sensor plate between the sensor grids without making contact with the grid. The test results are presented in Figure 4-6.

It appears that the sensors are maintaining a temperature above 4° when the ambient temperature is lower than 4°C, however the data indicate that the sensor heaters may still be activated when the ambient temperature is above 4°C.

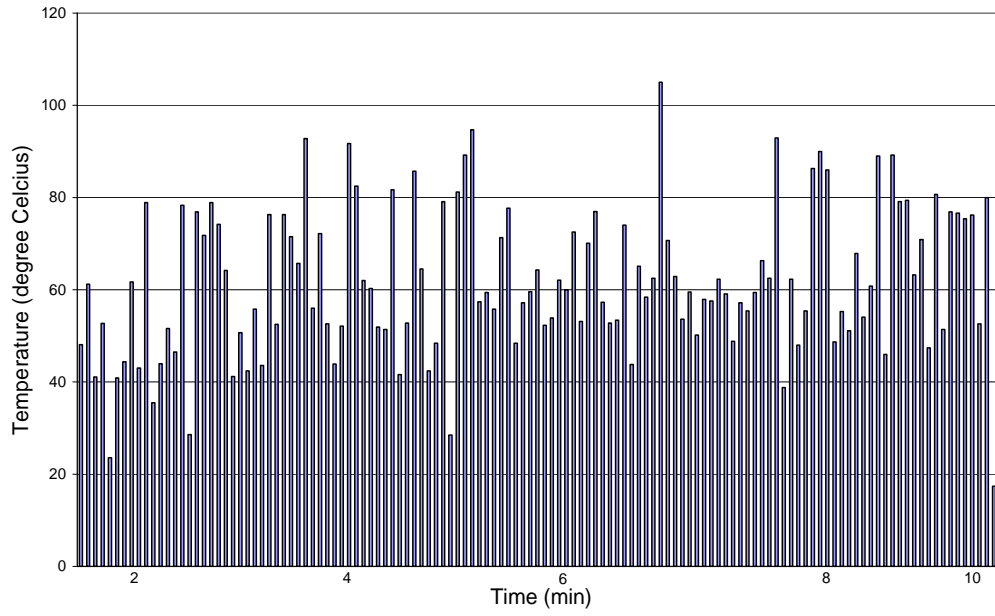
Figure 4-7. Activated Sensor Temperature and Elapsed Time

Figure 4-7 presents the maximum temperature reached by each sensor when activated, and the time required for each sensor to reach that temperature. There seems to be considerable variability between sensors for maximum temperature, but nearly all sensors are generally around 60°C prior to 10 minutes of activation.

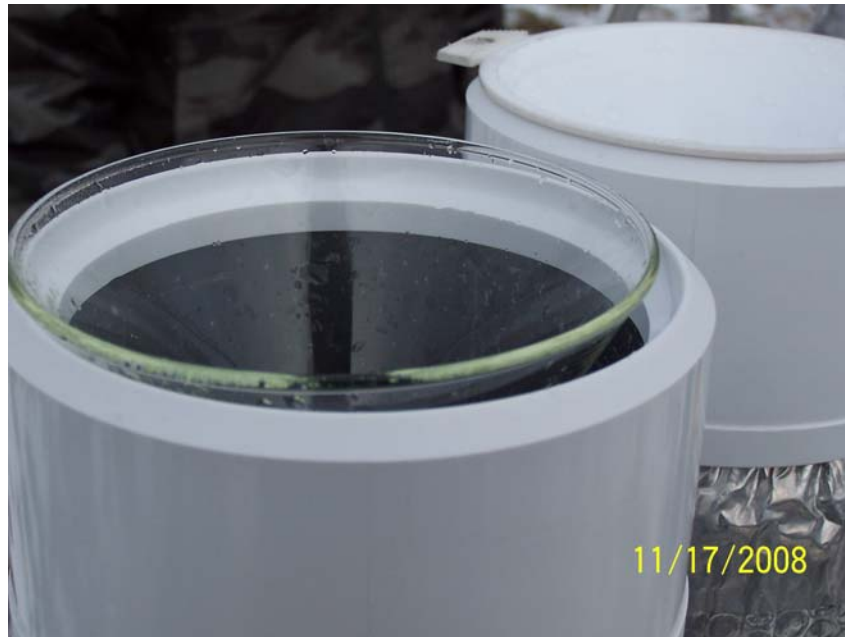
Figure 5-1. MDN Funnel to Chimney Seal

In a number of cases water appears to seep between the funnel and chimney. This is especially prevalent during events with high winds. This has the potential to cause confusion regarding the source of the liquid in the over-flow container and possibly the Quality Rating (QR) code of the sample. Figure 5-1 shows a typical funnel/chimney position during sample collection. Perhaps a different chimney cap material that would produce a better seal between the funnel and the chimney itself could be investigated to help solve this problem.
