2010 National Atmospheric Deposition Program Site Survey Program Annual Report

**U.S. Environmental Protection Agency
Office of Atmospheric Programs**

June 2011

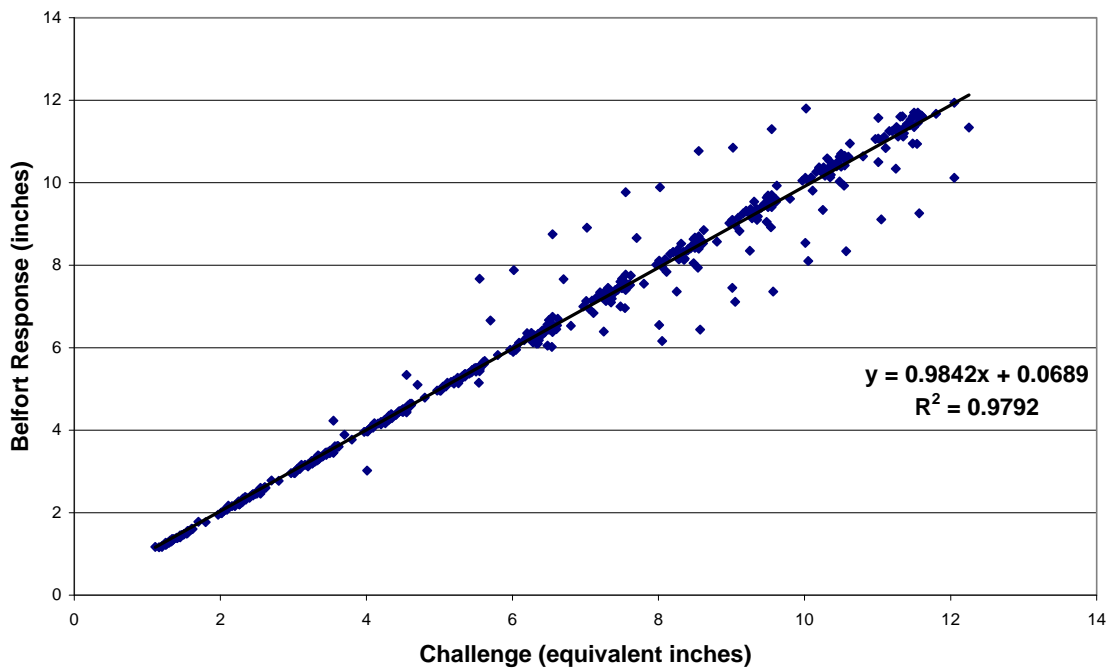
Figure 4-1. As Found Belfort Accuracy Results - 47 Gages

Overall program-wide Belfort raingage accuracy was found to be very good with a slope of approximately 98% and a correlation of 0.9792. A relatively few number of sites were not performing well and are easily identifiable in Figure 4-1.

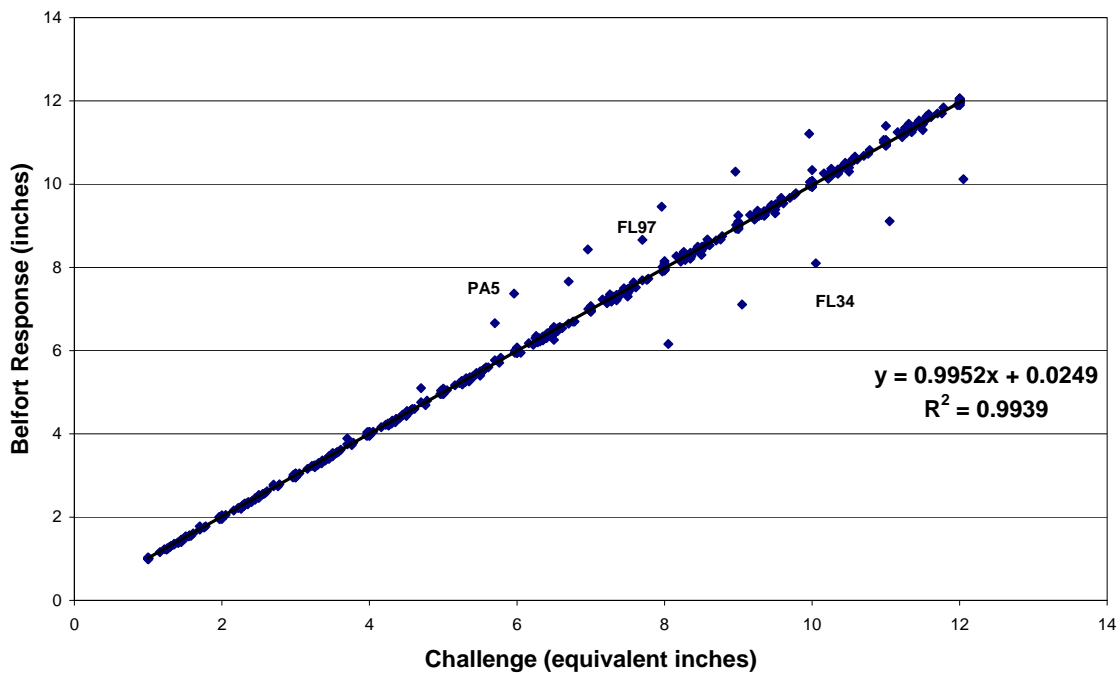
Figure 4-2. As Left Belfort Accuracy - 47 Gages

Figure 4-2 presents the “as left” Belfort raingage accuracy results for all gages encountered following any adjustments or improvements to the operation. Adjustments include leveling, cleaning, adjusting linkage, and calibration. Overall program-wide accuracy was improved as the results indicate with a slope of approximately 99.5 % and a correlation of 0.9939, however there were still some gages that could not be adjusted to within the tolerance of 0.10 inch throughout the entire range of 0-12 inches. The three sites that were not able to be adjusted to within acceptable limits were PA52, FL34, and FL97. All three gages were due to be replaced with electronic gages shortly after the survey visits.

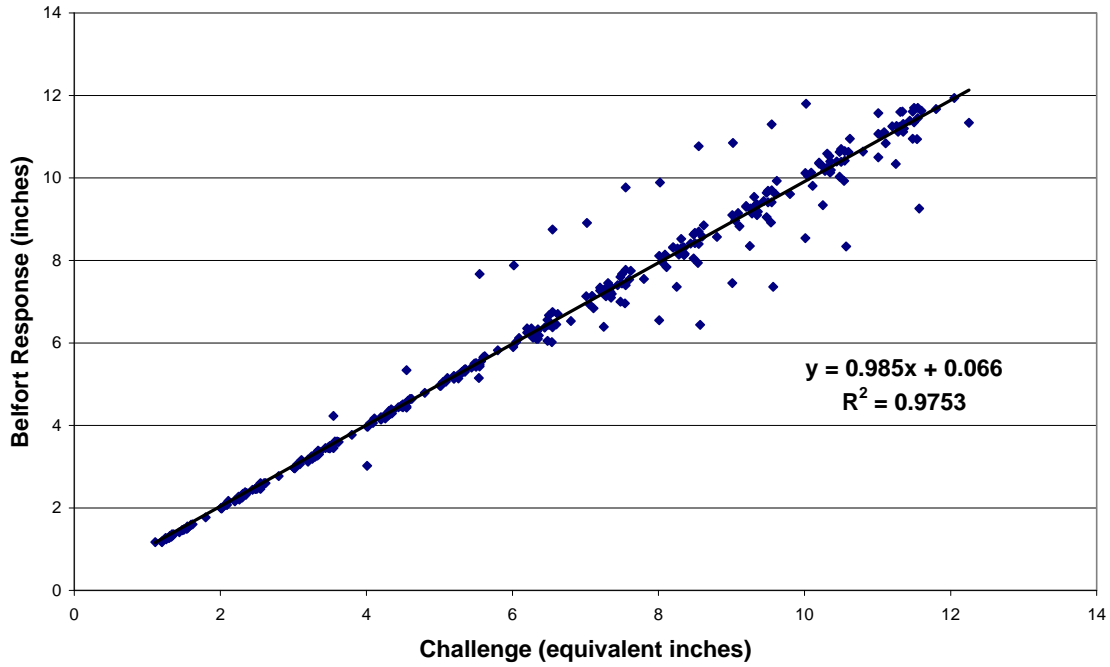
Figure 4-3. As Found Belfort Accuracy - 31 Adjusted Gages

Of the 47 Belfort gages encountered, 31 gages required some type of adjustment. Only data from Belfort gages that were adjusted during the survey are presented in this subsection. Gages that were already within tolerance or could not be adjusted² to within tolerance are not included. Figure 4-3 presents the “unadjusted” calibration results and Figure 4-4 presents the results after adjustments and calibration. There is a noticeable decrease in accuracy observed in points above six inches in Figure 4-3. This is mostly attributed to improper gage turnover which was discussed in Section 3.0 and will be addressed again in Section 6.0 of this report.

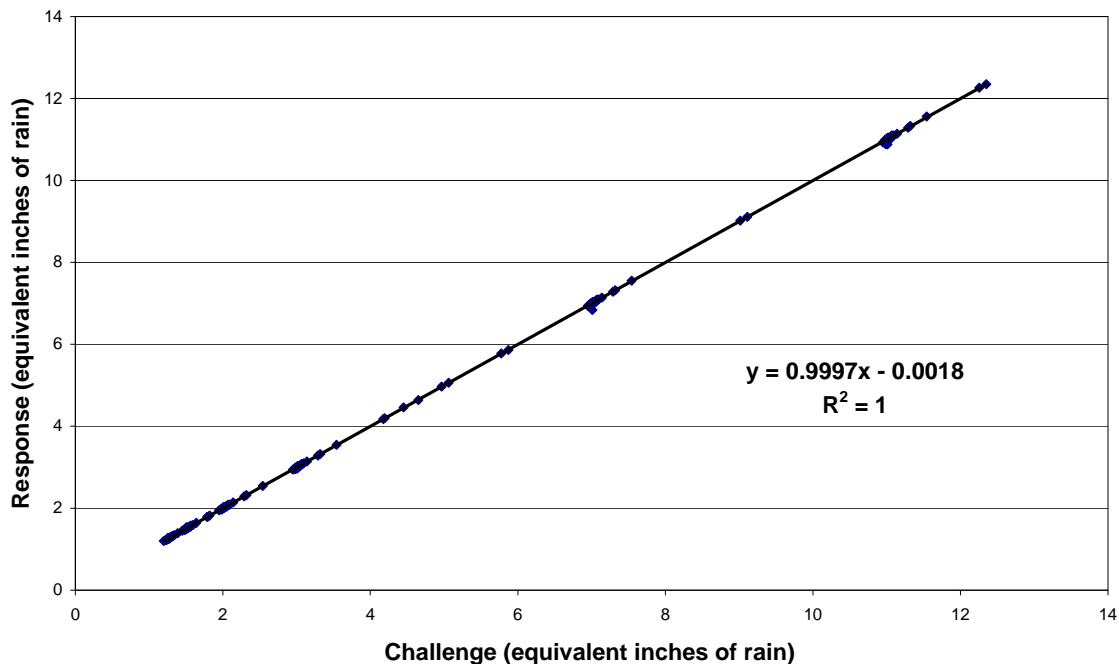
Figure 4-5. As Found Electronic Gage Accuracy - 37 Gages

The results of the accuracy tests for the 37 electronic raingages (KY03 was not challenged due to communication problem with the DAS) challenged during the period covered by this report are presented in Figure 4-5. As clearly indicated the gages report the weight of the standards added very accurately for the entire span. No problems were encountered and no adjustments were required for the electronic gages. The only notable problem with the electronic gage operation is related to the Personal Digital Assistant (PDA) and the required interfacing software. This is discussed further in Section 5.0.

Although not clearly seen in Figure 4-5, one electronic gage at site MD00 was not within acceptance limits when tested during the survey. The CAL was notified during the survey visit to determine what further action would be required to adjust the gage.

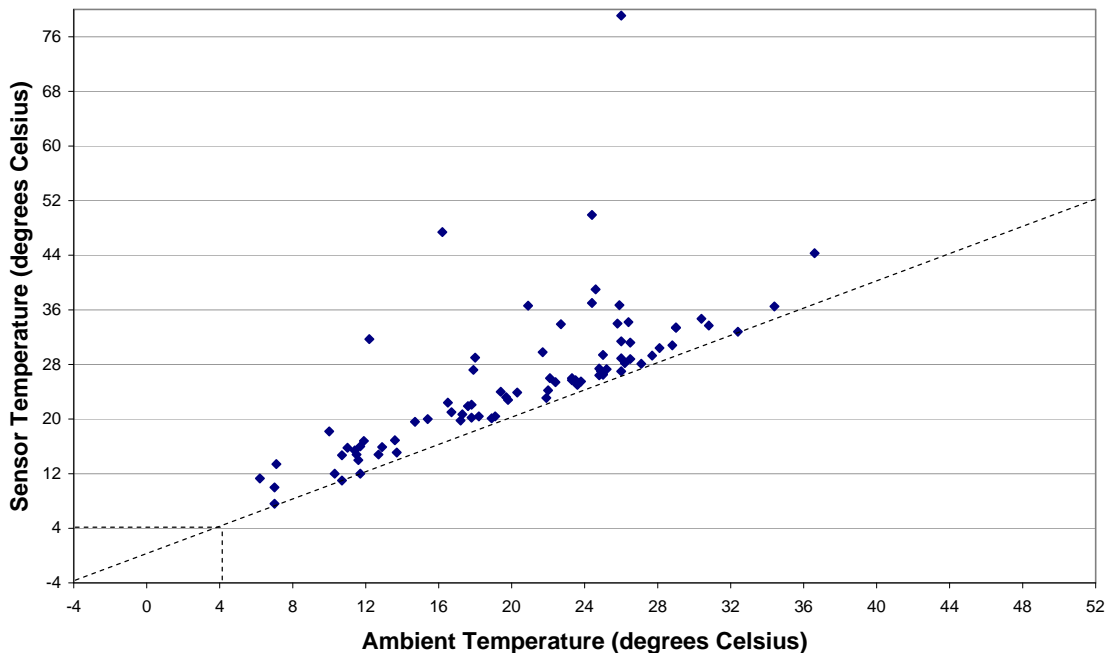
Figure 4-6. Inactivated Sensor Temperature

The inactive sensor temperature tests are conducted using a thermocouple with the sensor shaded immediately after measuring the ambient temperature with the same device. The thin thermocouple is placed directly on the sensor plate between the sensor grids without making contact with the grid. The test results are presented in Figure 4-6.

It appears that data from this year might reflect more careful methods applied by the field technicians. Most of the sensors were found just a few degrees above ambient temperature. Since the measurement is made after shading the sensor and measuring the ambient temperature, a difference of just a few degrees seems reasonable since it would take some time for the sensor to cool after absorbing heat prior to shading. By comparing this graph to that of last year, less scatter and more points just above and parallel to the line can be observed.

It was determined from these two sensor tests that three sensors were not functioning properly. One sensor (CA20-MDN) reached nearly 140 degrees within the first minute and it was also hot when not activated. Another heater was always on (MO46-MDN) and the temperature was constantly nearly 80 degrees. A third sensor heater (PA42-NTN) did not function at all when activated and remained at ambient temperature. Replacements for all of these sensors were requested. Two other sites had sensors that were warm when not active, but both were tested when the ambient temperature was high, and it may have required more time for the sensors to cool to ambient conditions. Therefore replacements for these were not requested.

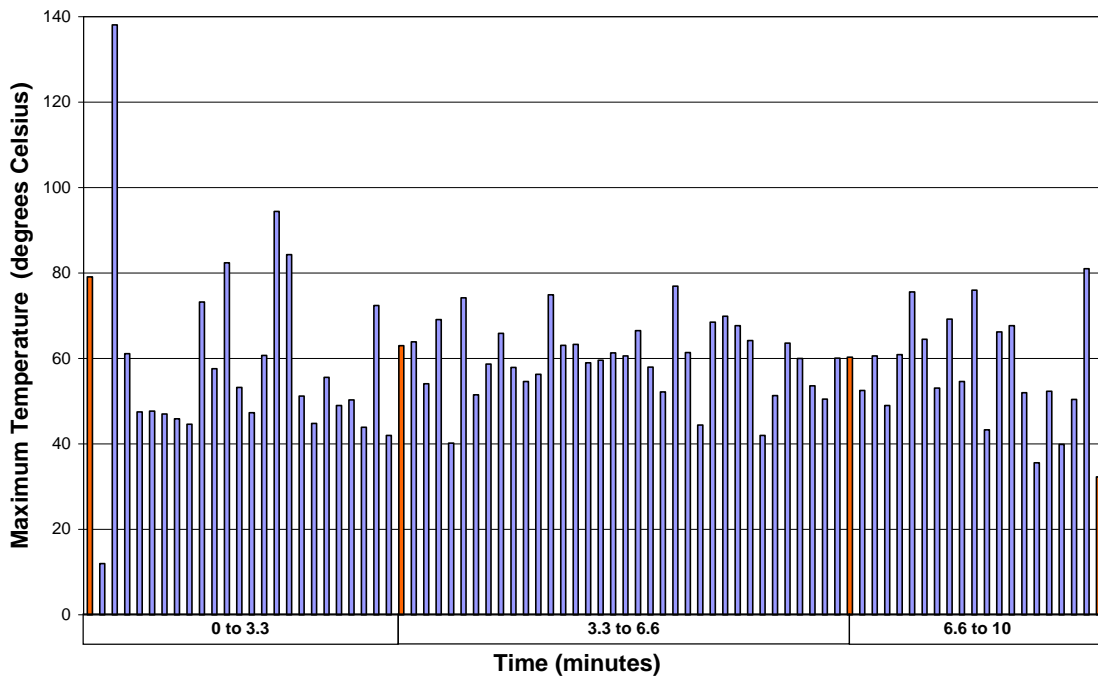
Figure 4-7. Activated Sensor Temperature and Elapsed Time

Figure 4-7 presents the maximum temperature reached by each sensor when activated, and the time required for each sensor to reach that temperature. There seems to be considerable variability between sensors for maximum temperature, but nearly all sensors are generally around 60°C prior to 10 minutes of activation.

As indicated in the figure, one sensor reached a temperature of nearly 140 degrees with the first minute of activation. The sensor was in operation at site CA20-MDN and was flagged as not operating properly and a replacement sensor was requested.
