2014 National Atmospheric Deposition Program Site Survey Program Annual Report

**U.S. Environmental Protection Agency
Office of Atmospheric Programs**

Contract No.: EP-W-12-019

August 2015

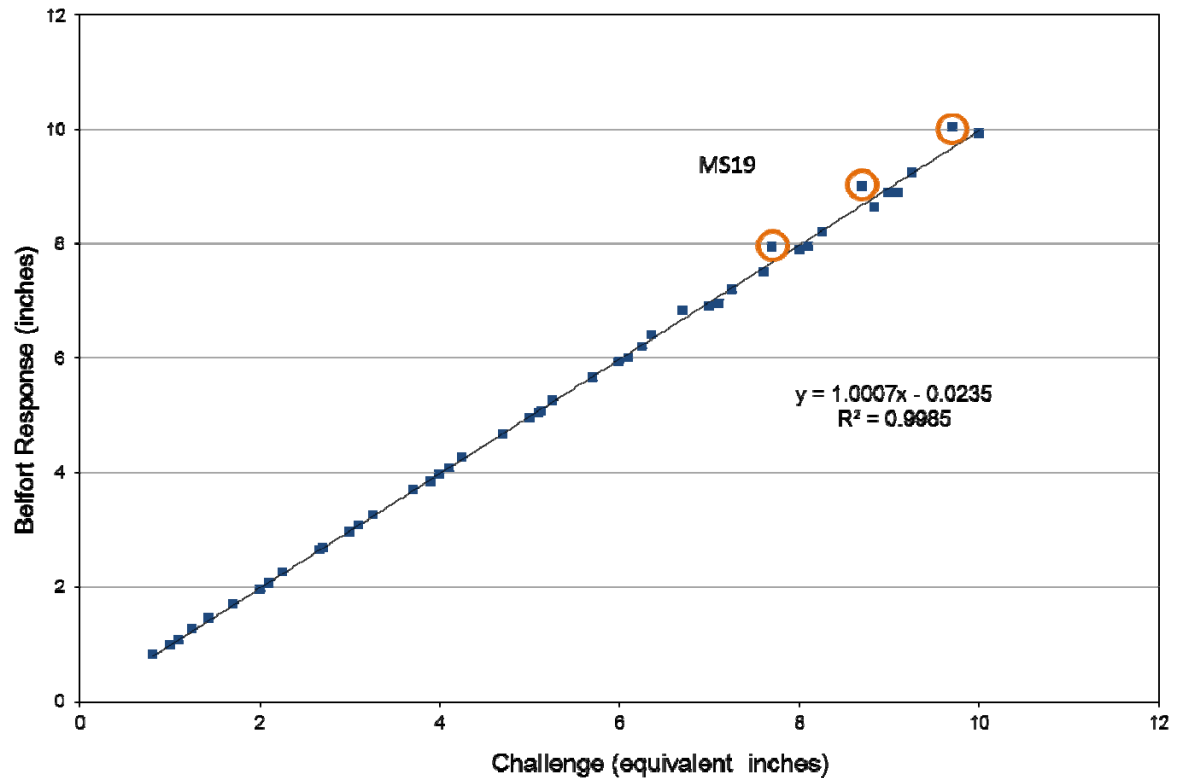
Figure 4-4. As Left Belfort Accuracy - Five Adjusted Gages

Of the nine Belfort gages encountered, five gages required some type of adjustment. Only data from Belfort gages that were adjusted during the survey are presented in this subsection. Gages that were already within tolerance or could not be adjusted to within tolerance are not included. Figure 4-3 presents the “unadjusted” calibration results and Figure 4-4 presents the results after adjustments and calibration. There is a noticeable decrease in accuracy observed in points above six inches in Figure 4-3. This is mostly attributed to improper gage turnover which is discussed in Section 6.0 of this report.
